**TRAFFIC SAFETY
IMPROVEMENT STUDY**

WO No. 91-06

CITY OF BILLINGS

MA **MARVIN & ASSOCIATES**
Traffic, Transportation & Civil Engineers

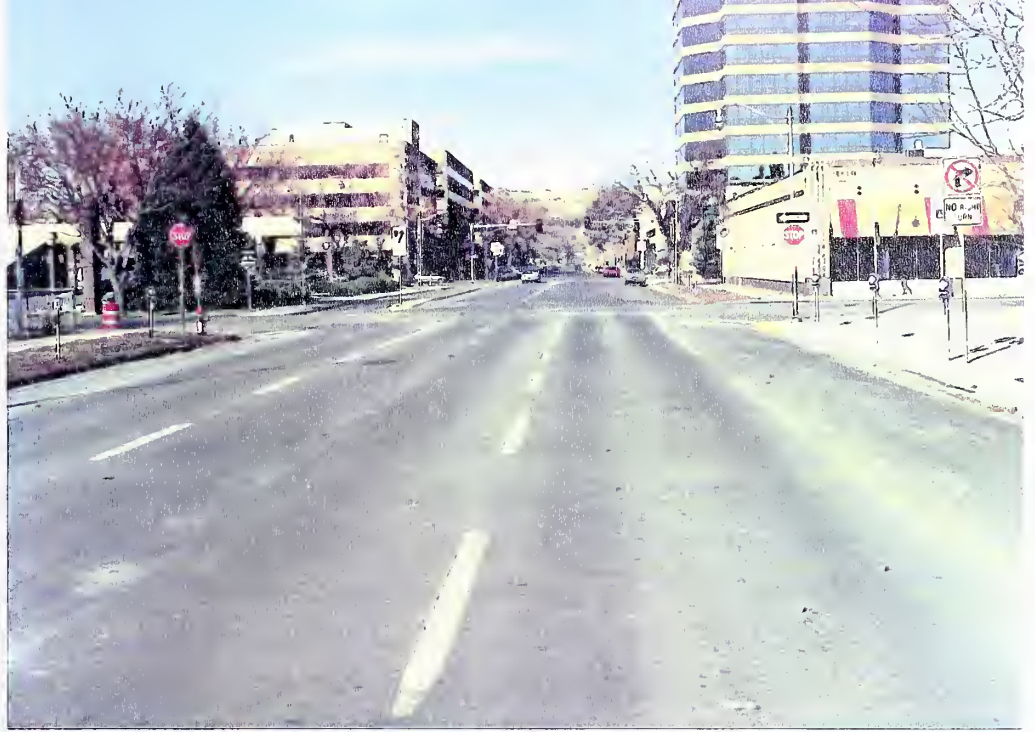
N. 31ST ST. LOOKING NORTH

Because of the relatively high traffic volumes at this intersection a signal warrant analysis was completed. A summary of that analysis can be found at end of this section. None of the signal warrants were met at this intersection. Warrant number 8, combination of warrants was 75% met on the minor leg. Four hour volume and peak hour volume warrants were also close. From this analysis, the only warrant that may be met is the accident experience warrant. However, other improvements must be tried prior to installing a signal based on that warrant.

sight distance. Based on this analysis, parking would have to be removed for a half block to attain required sight distance and this intersection is located in an area where parking is at a premium. As an alternative, bulb island curbs on the south side of the street was evaluated. Because this alternative would only remove 2 parking spaces; reduce the critical vehicular crossing gap; reduce the width of crossing for pedestrians; and provide an improved location to mount stop signs, it is the recommended improvement. New stop signs should be oversized to catch drivers attention which is important at this location where drivers are required to monitor a number of different activities beyond navigation. Better alignment of the lane markings on the 31st Street approach and thru the intersection along with plastic words and symbols will also help confusion and decrease driver information load.

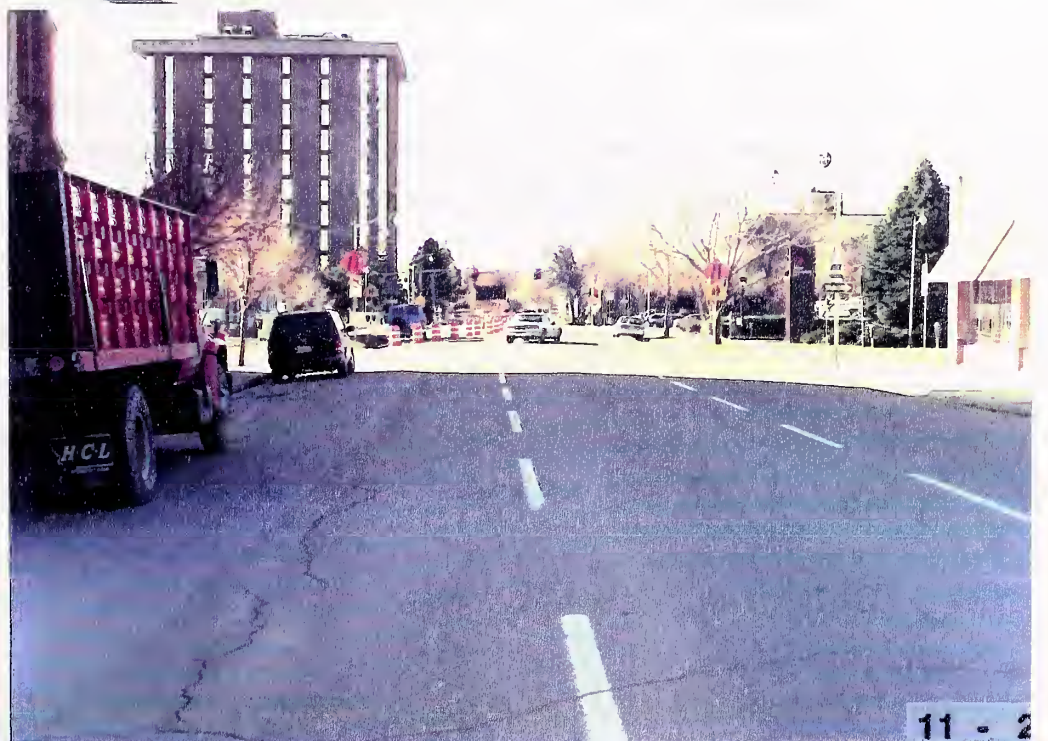
Third Ave N. and N. 31st Streets are two one-way CBD streets. Third Ave is one-way westbound and N. 31st is one-way northbound. Both streets are typical of streets in the CBD since they both have three traffic lanes in a 50' street section with parking on both sides. This intersection is also typical of other CBD intersections in that pedestrian activity requires vehicles to stop well behind the curb radii which limits sight distance along the intersecting street. Since a significant number of intersections in the CBD are signalized, this is not usually a major problem. In this case, northbound traffic is controlled by stop signs. The existence of wide streets, multi-lanes and curb side parking combine to present high probability conditions for angle accidents.

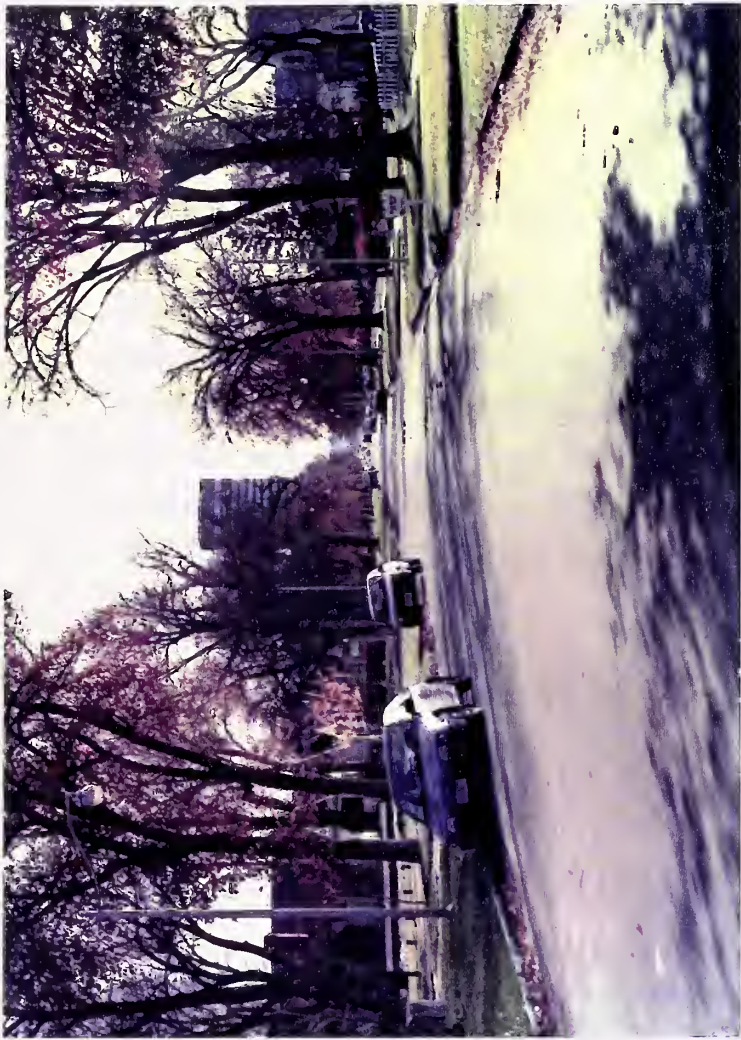
N. 31ST ST. LOOKING SOUTH

Tenth Avenue N. and N. 31st Street are local streets within a residential neighborhood on the fringe of the Medical Corridor area. They are narrow two lane streets with parking on both sides. When vehicles are parked on these 31' streets, there is barely enough room for two vehicles to pass. Fortunately, traffic volumes are low. There were six angle accidents at this intersection during the reporting period along with 6 other accident types which reflect the narrow street conditions.

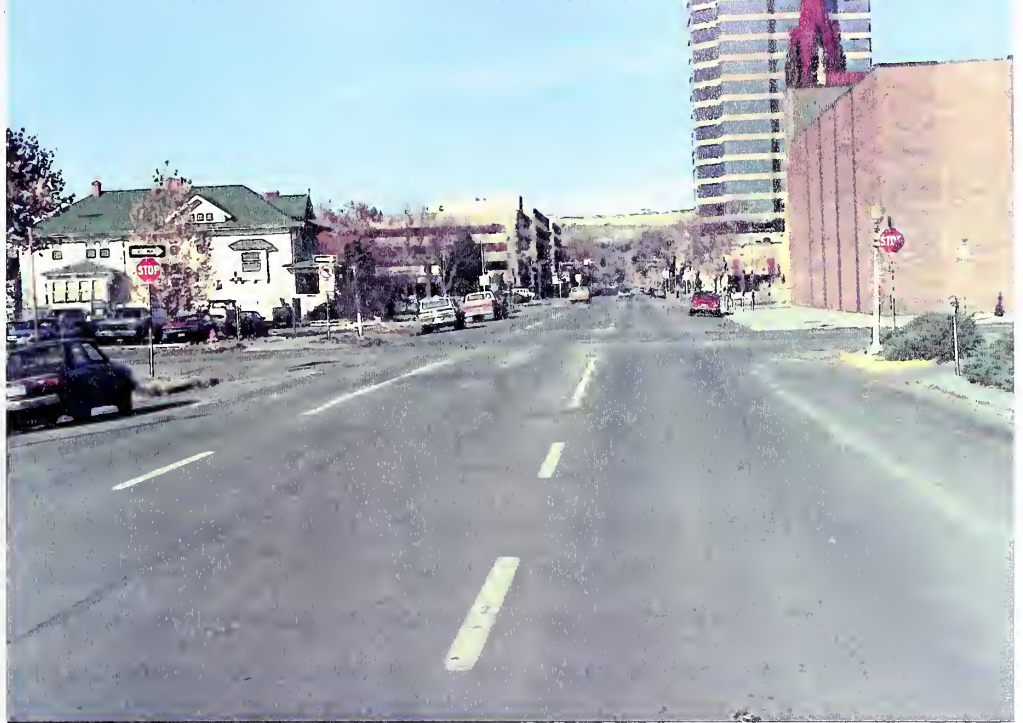
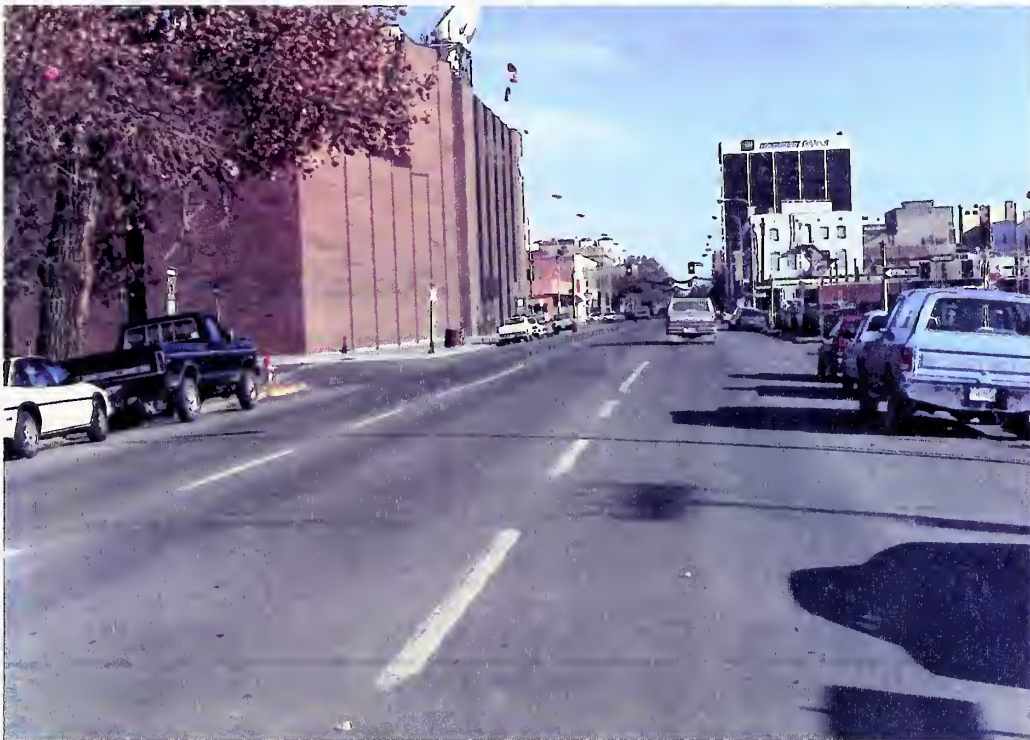
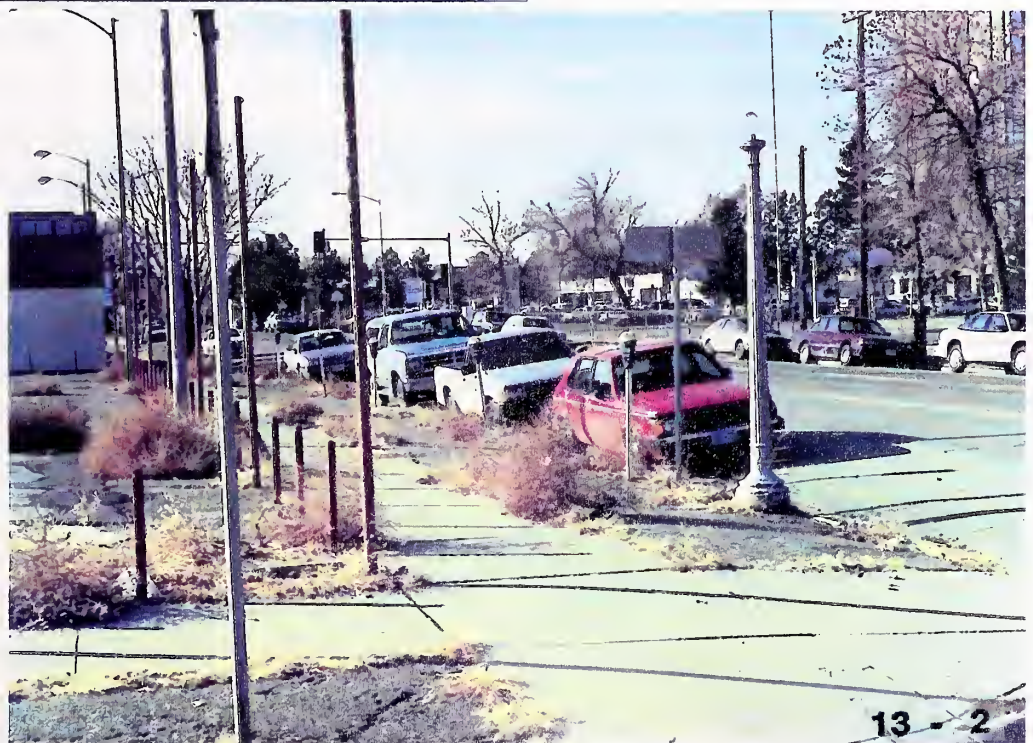
N. 31ST ST. LOOKING NORTH

Second Ave N. and N. 31st Streets are two one-way CBD streets. Second Avenue is one-way eastbound and N. 31st is one-way northbound. Both streets are typical of streets in the CBD since they both have three traffic lanes in a 50' street section with parking on both sides. This intersection is also typical of other CBD intersections in that pedestrian activity requires vehicles to stop well behind the curb radii which limits sight distance along the intersecting street. Since a significant number of intersections in the CBD are signalized, this is not usually a major problem. In this case, northbound traffic is controlled by stop signs. The existence of wide streets, multi-lanes and curb side parking combine to present high probability conditions for angle accidents.

sight distance. Based on this analysis, parking would have to be removed for a half block to attain required sight distance and this intersection is located in an area where parking is at a premium. As an alternative, bulb island curbs on the south side of the street was evaluated. Because this alternative would only remove 2 parking spaces; reduce the critical vehicular crossing gap; reduce the width of crossing for pedestrians; and provide an improved location to mount stop signs, it is the recommended improvement. New stop signs should be oversized to catch drivers attention which is important at this location where drivers are required to monitor a number of different activities beyond navigation.

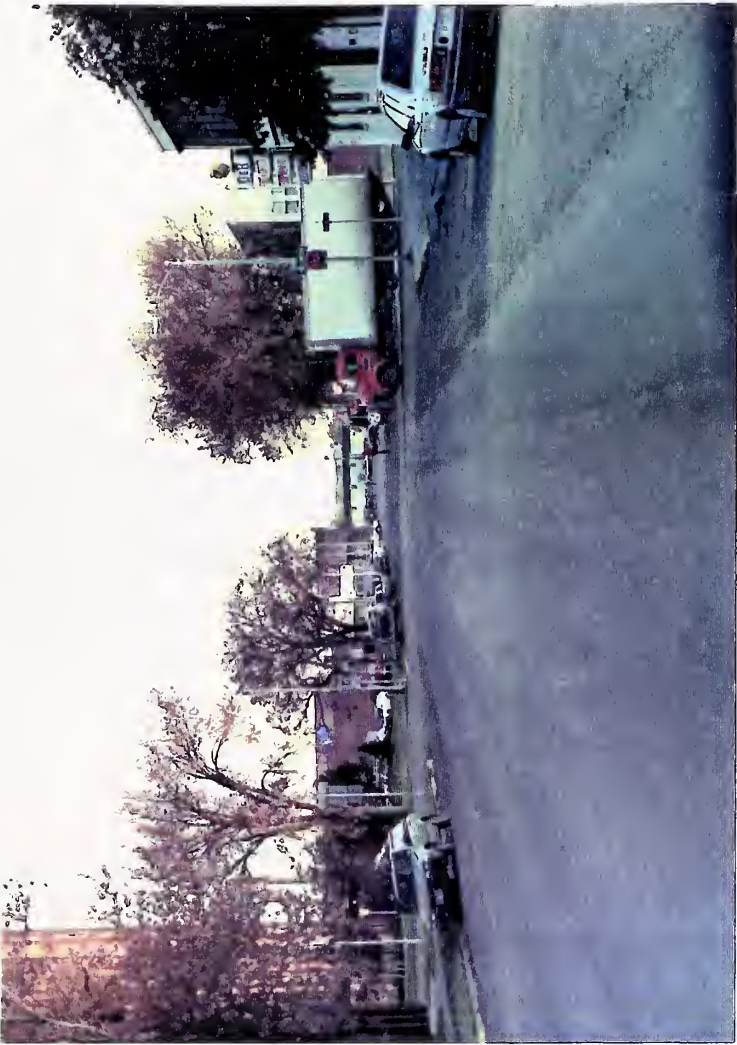
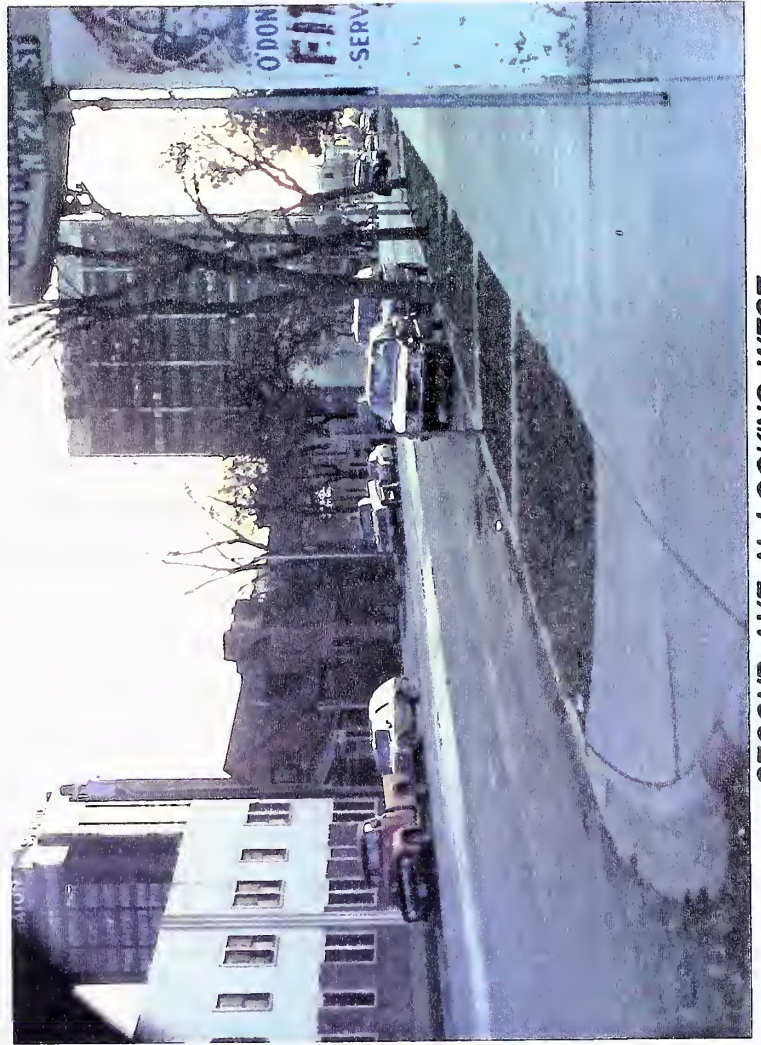
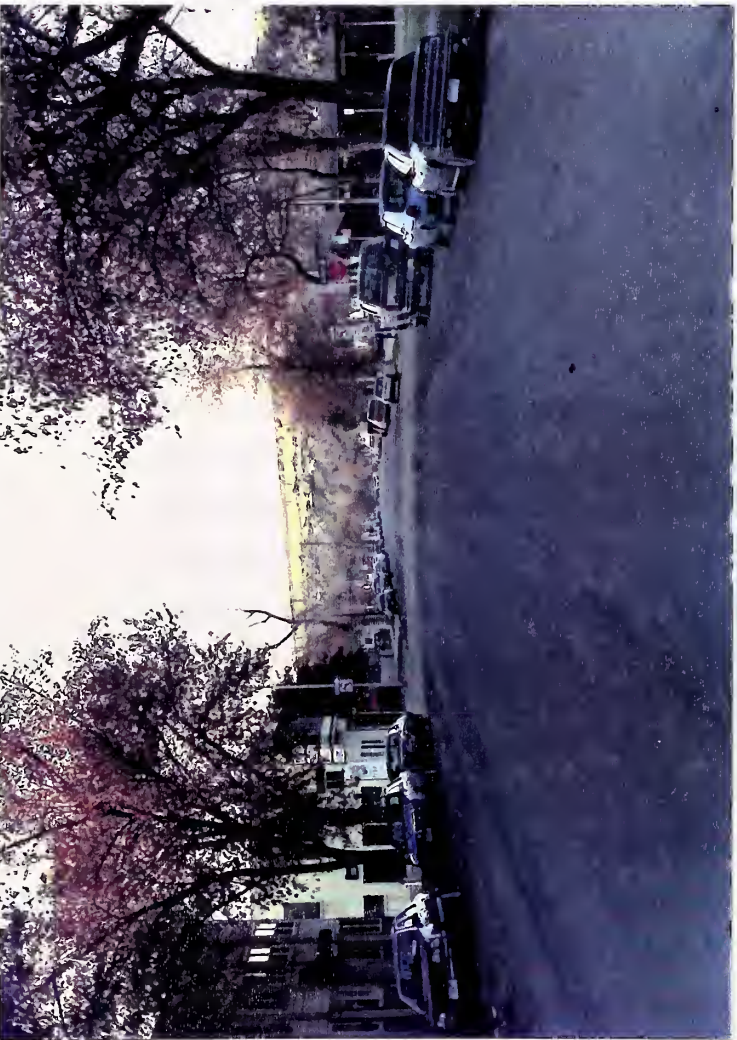
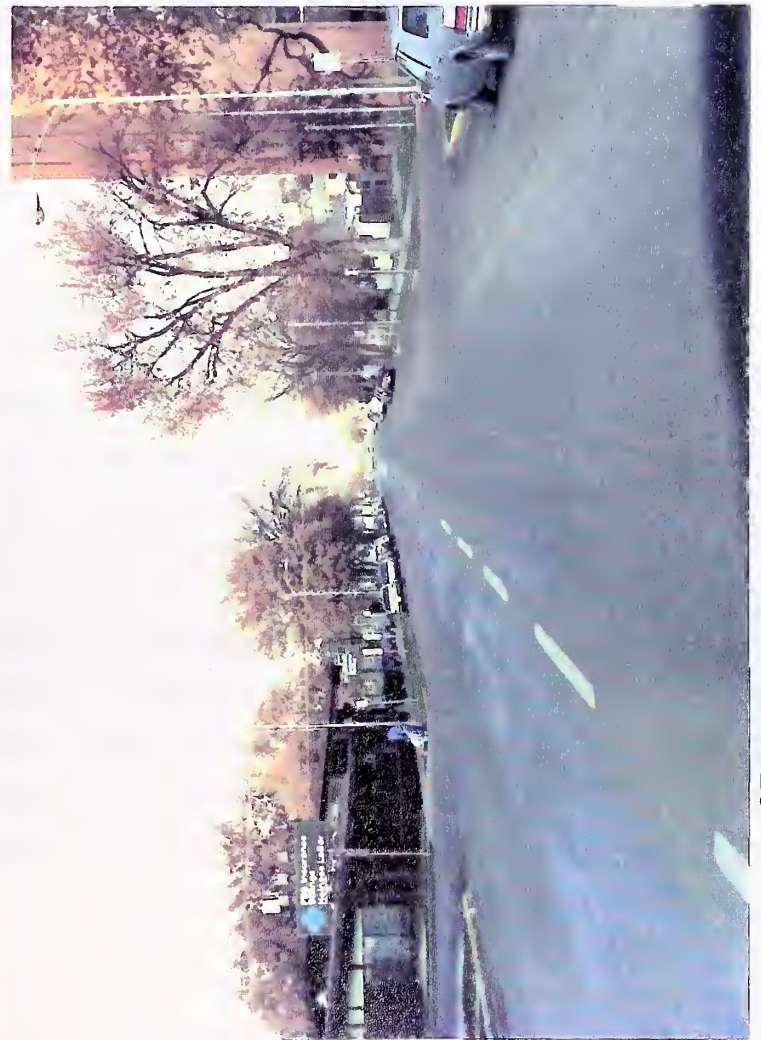
It is apparent that sight distance improvements are required at this intersection. A dynamic vehicle model using average acceleration rate for a single unit design vehicle was used to calculate critical gaps and required sight distance. Based on this analysis, parking would have to be removed for a distance of 60 feet on 2nd Avenue west of the intersection to provide minimum sight distance. The parking restrictions should be signed and curbs painted yellow to emphasize these zone restrictions. Yellow curb paint 30' in advance of the northbound stop sign is also recommended. New stop signs should be oversized to catch drivers attention. The new sign in the southeast corner should be located closer to the curb using a cantilever mounting. In addition, stop bars and centerline markings should be painted on the N. 24th approaches to provide additional reinforcement of the stop condition.

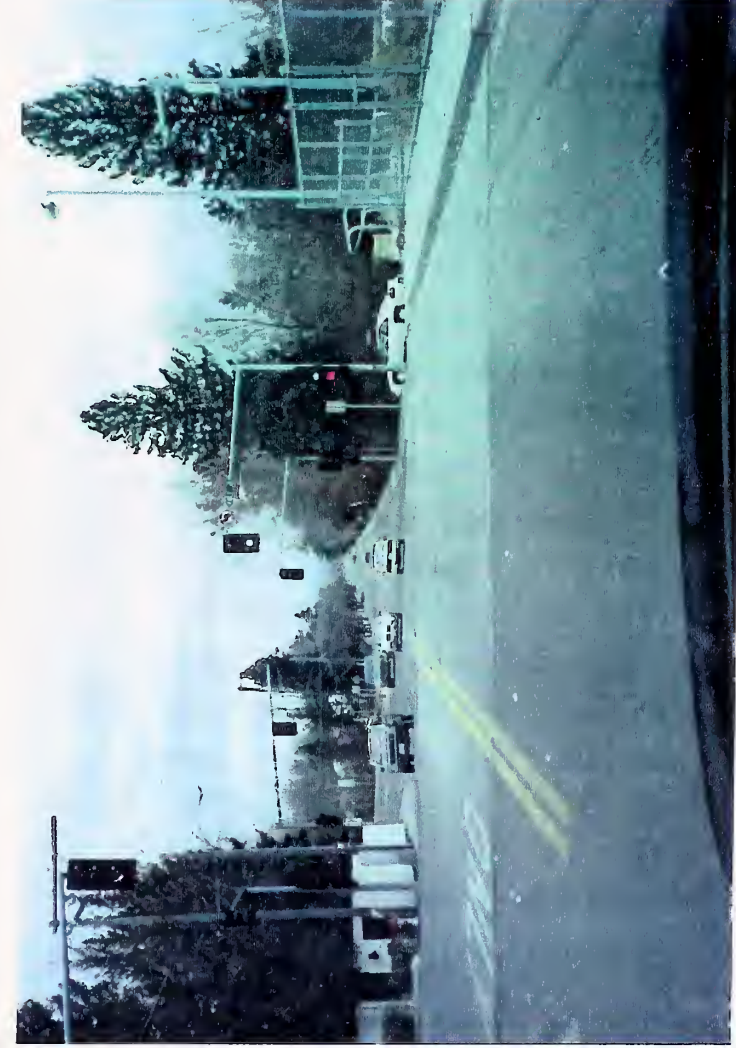
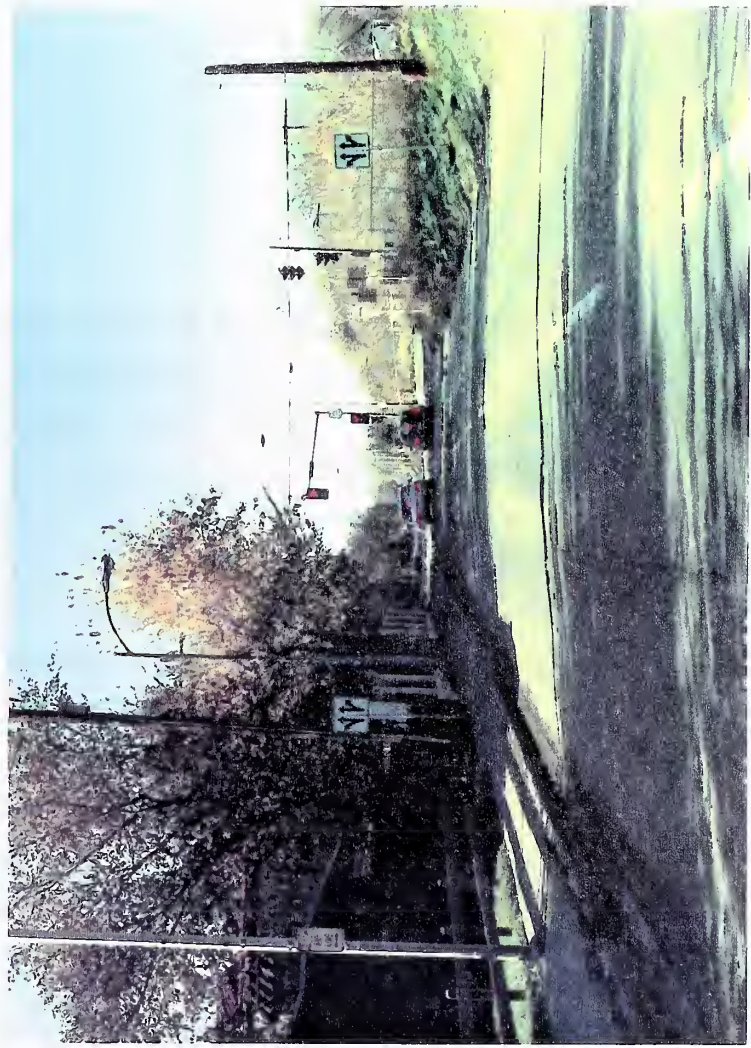
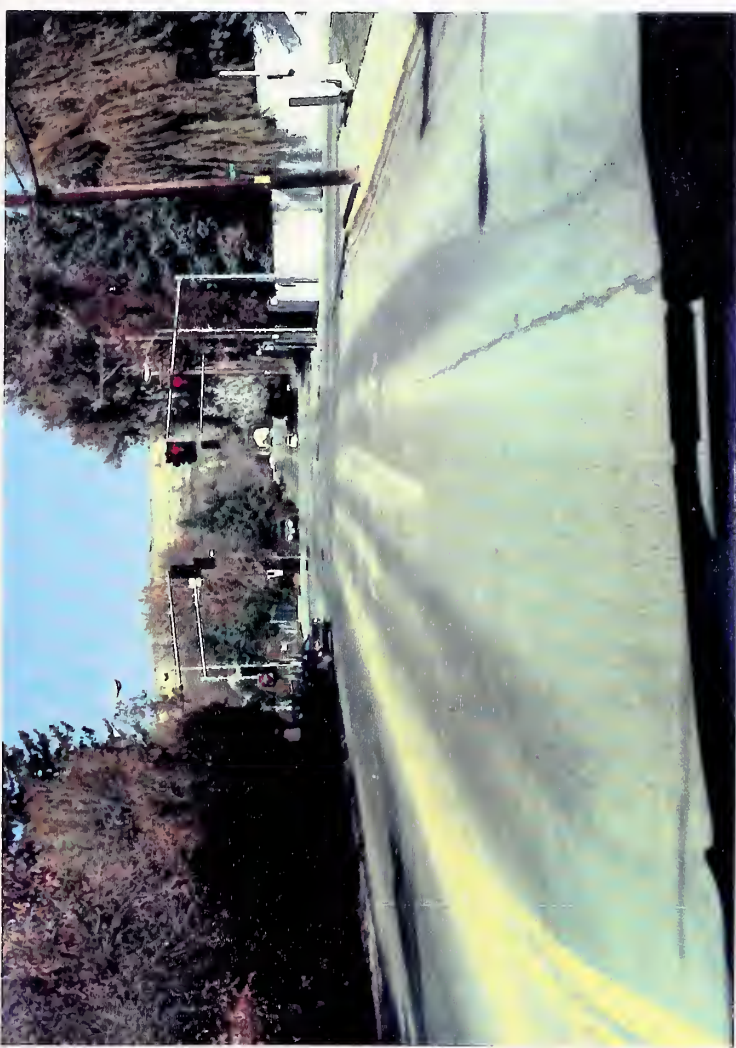
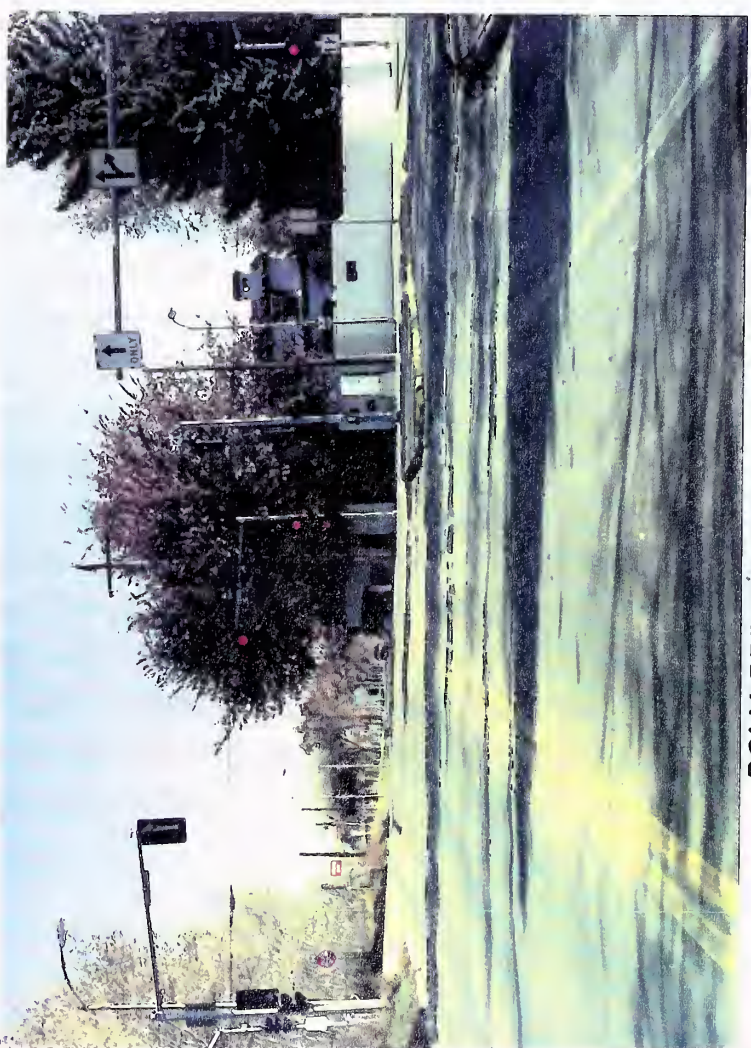
The intersection geometry and traffic control system is highly complex. It was originally constructed in 1973 as part of the old TOPICS program. In 1989, an old narrow bridge on the north side of the intersection was replaced with the existing bridge and approach work was constructed. During that construction, new traffic detectors were installed in the bridge to replace those that had been installed in 1973 which had long since ceased to function. With the 1989 improvements, the City's Traffic Signal Section was able to reprogram signal control at the intersection to take advantage of full signal accuation. Since reprogramming has occurred, the intersection operates many times more efficiently.

There were 10 angle accidents and 7 rearend accidents at this intersection during the reporting period. The accident rate at this intersection is not abnormally high in relationship to signalized intersections in Billings, but the number of accidents is quite high. Observations of the intersection operation indicated that traffic moves through the intersection without many conflicts. The only area of potential conflicts observed was in the trap area between the dual signal indications for north and south traffic. It was also observed that at least one westbound vehicle entered the intersection at the beginning of the red interval on every cycle during peak hours. The only conflict this presents is to vehicles who may have been waiting for a green within the trap area. This situation probably only occurs on every 10th cycle.

The most consistent angle accident problem seems to be those involving northbound and eastbound traffic. Several recommendations are made to reduce the potential for these accidents. A dynamic vehicle model based on a single unit vehicle (truck or bus) was used to model the northbound movements. It was found that the last car in a northbound queue of vehicles would require 8.0 seconds to leave the southern stop bar and clear the northern intersection. Currently there is 9.5 seconds programmed, including amber and all-red intervals. This only allows 1.5 seconds margin for slower drivers. Slower drivers will likely have to stop for the second set of signals and thus be exposed to that last westbound vehicle which always runs the red. To reduce the possibility of this occurrence, it is recommended that the OLB green interval be increased by 2.0 seconds. As further insurance the westbound all-red interval should be increased by 1 second. In addition, westbound signal indications should be replaced with 12"X12"x12" signal heads to increase driver perception.

In order to reduce rearend accidents occurring in eastbound traffic rearend several other recommendations are made. The existing amber indication is 3.0 seconds. This should be increased to 4.0 seconds. An additional signal head should be added to the island traffic signal pole so that eastbound traffic has a more advanced indication of the hidden signals. The new indication

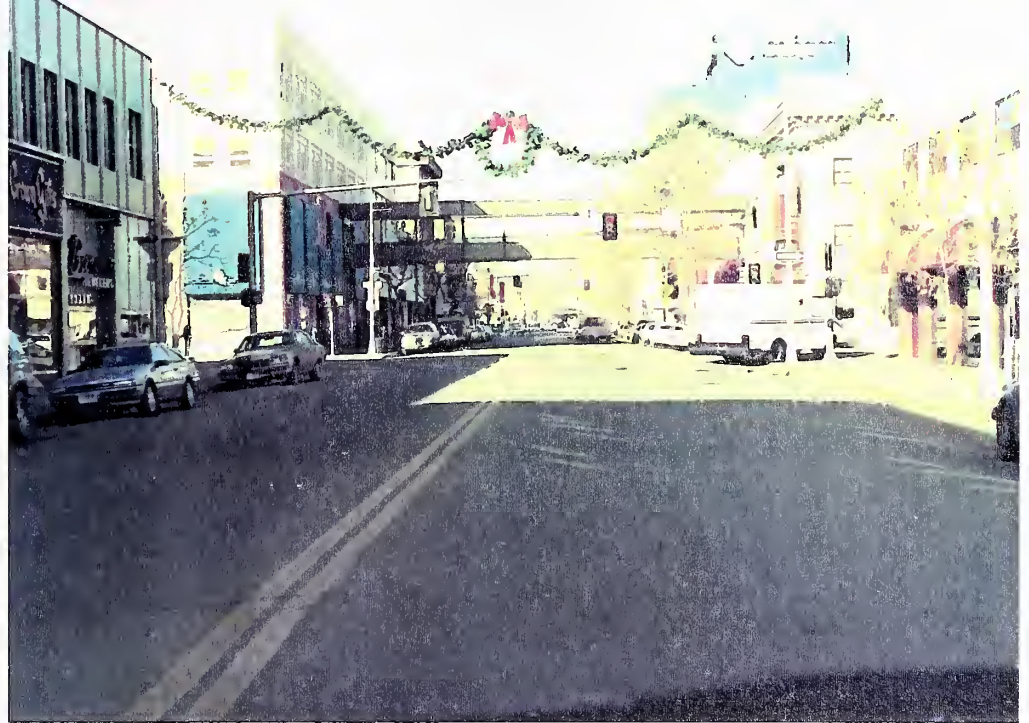
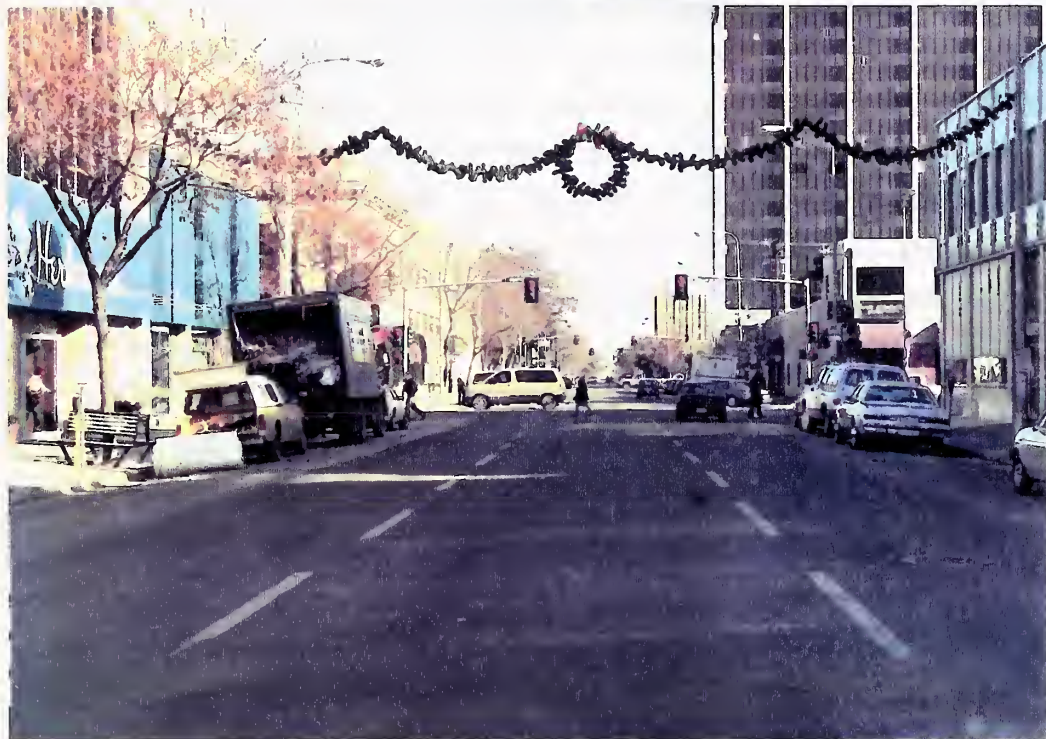
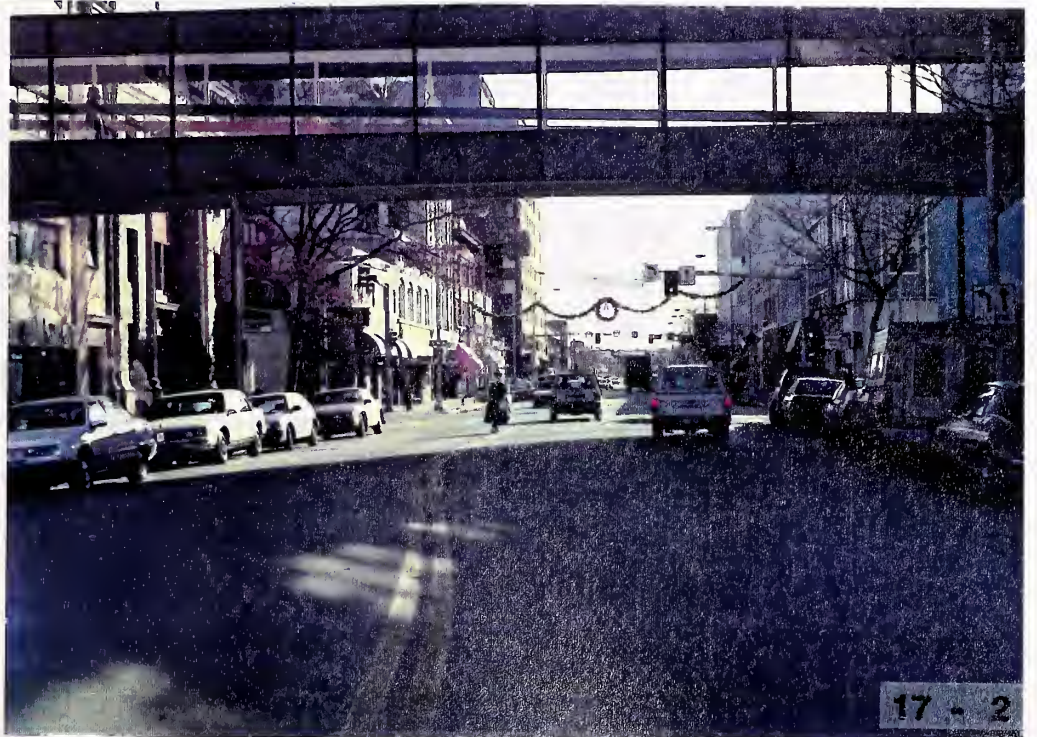
The intersection of Second Avenue N. and N. 28th Street is a signalized intersection in the core of the CBD. N. 28th Street is a two-way street with turn and thru lanes signed and marked. Second Avenue is a one-way street with three traffic lanes. There is parking on the both sides of both streets. Vehicular speeds are low and pedestrian traffic is high. There is a significant amount of turning movements at this intersection.

The most obvious condition noticed at this intersection is that the northbound thru lane overlaps into the southbound left turn lane, a situation which could not be eliminated without prohibiting parking for a significant distance and parking spaces are at a premium in this area. The signal is part of a coordinated system in the CBD. The system runs on a 70 second cycle from 7:30 to 5:30 and a 55 second cycle the remainder of the day. Progression is set on Second Avenue North. Because of heavy turning movements and pedestrian traffic, the center lane is usually the only traffic lane that fully enjoys this progression during peak hour periods.

Two recommendations are made to reduce the potential for angle accidents and potentially, rearend accidents. The all-red interval should be increased to 1.5 seconds. Because of the background cycle and similar accident experience at adjacent intersections it may be desirable to reset all of the signals on 2nd Avenue as well. In addition, existing mast arm signal heads should be replaced with 12"x12"x12" signal heads and in the case of northbound and southbound signals, the existing heads could be reused as a second mast arm indications to increase street approach coverage.

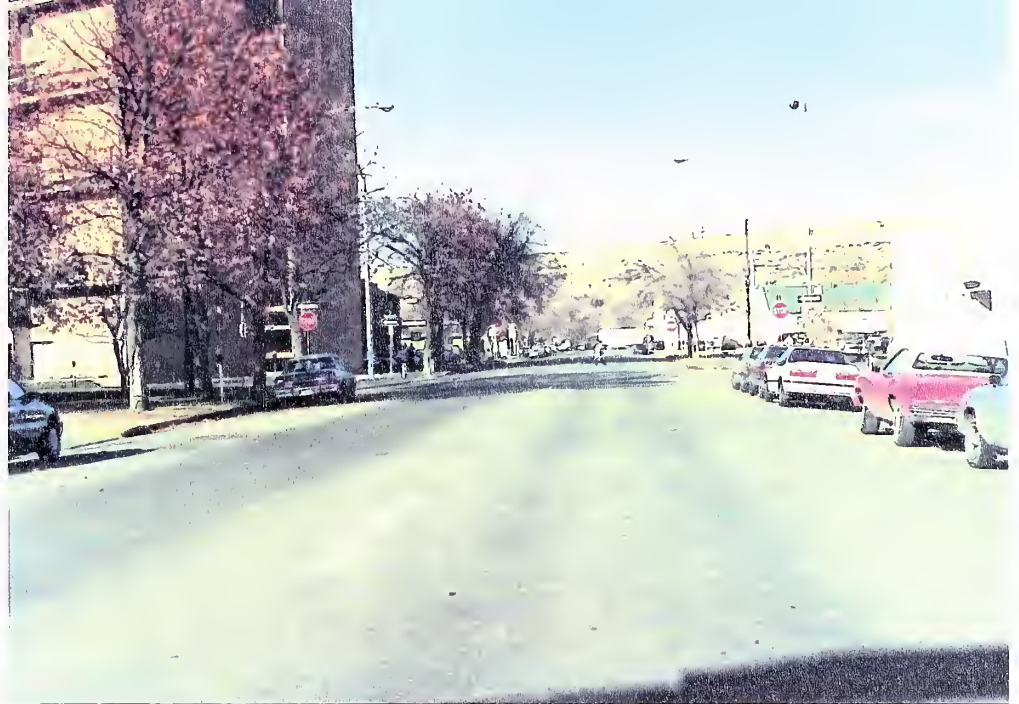
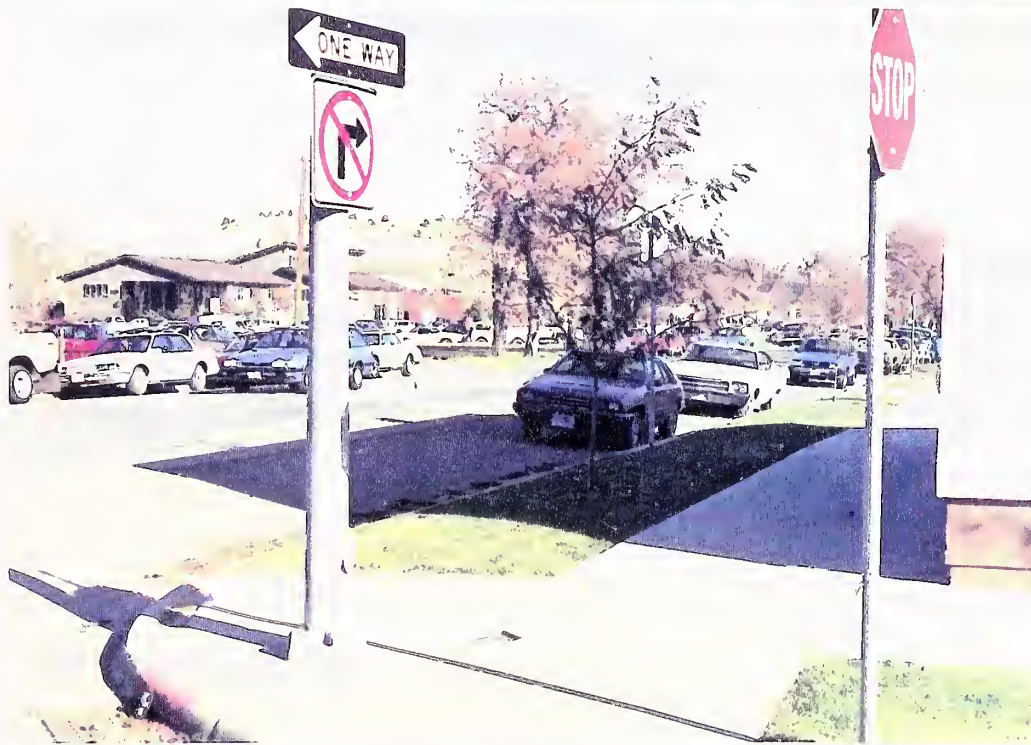
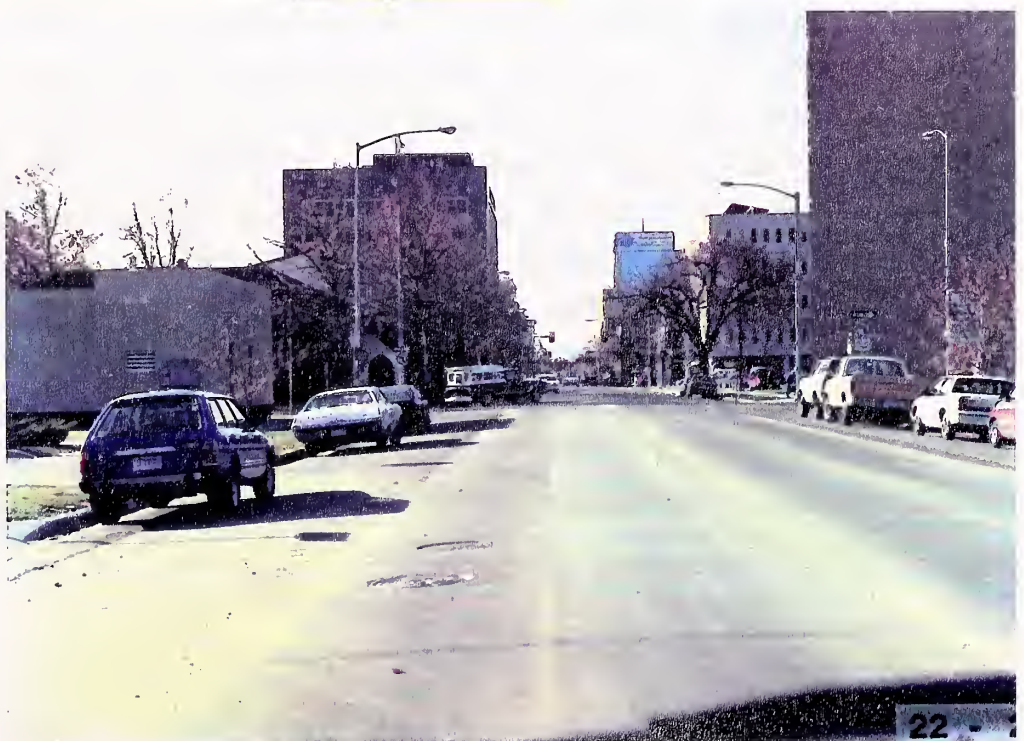
Third Ave N. and N. 25th Streets are two one-way CBD streets. Third Avenue is one-way westbound and N. 25th is one-way northbound. Both streets are not typical of streets in the CBD since they both have two, instead of three, traffic lanes in a 50' street section with parking on both sides. Pedestrian activity at this location is fairly heavy and requires vehicles to stop well behind the curb radii which limits sight distance along the intersecting street. Since a significant number of intersections in the CBD are signalized, this is not usually a major problem. In this case, northbound traffic is controlled by stop signs. The existence of wide streets, multi-lanes and curb side parking combine to present high probability conditions for angle accidents.

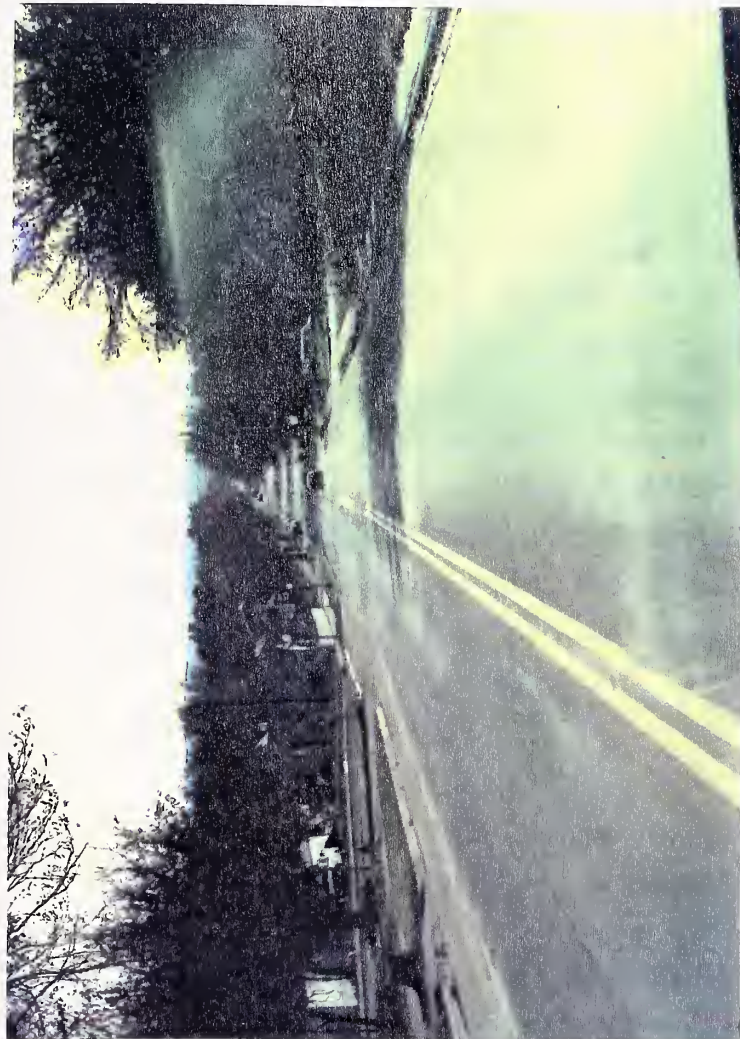
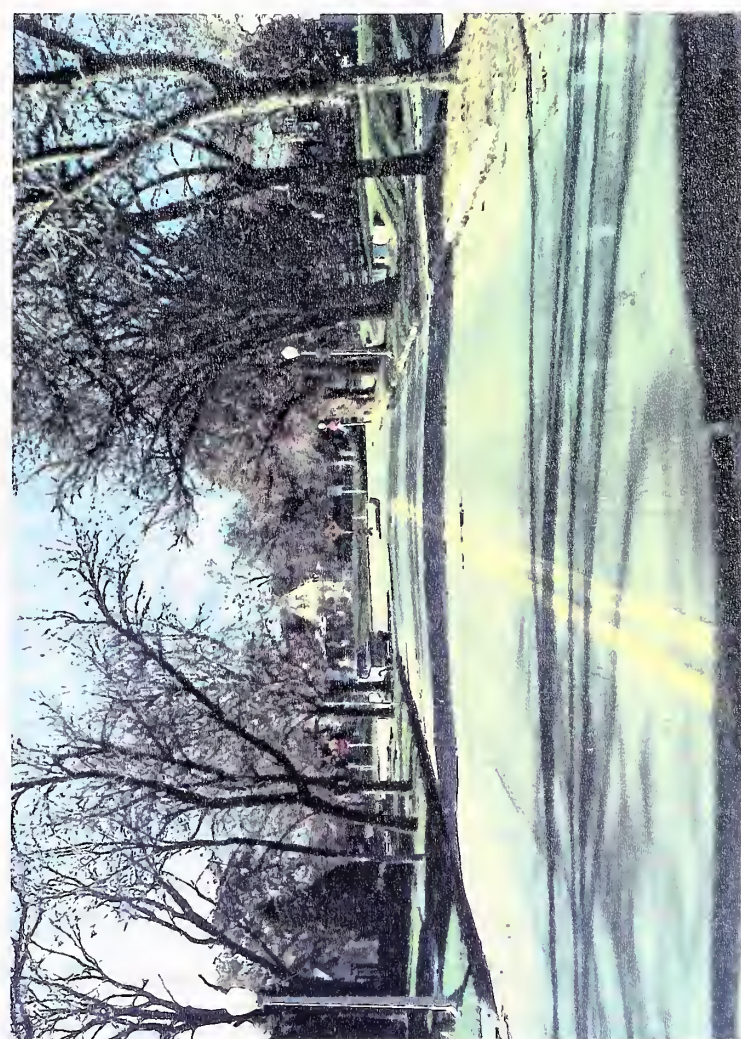
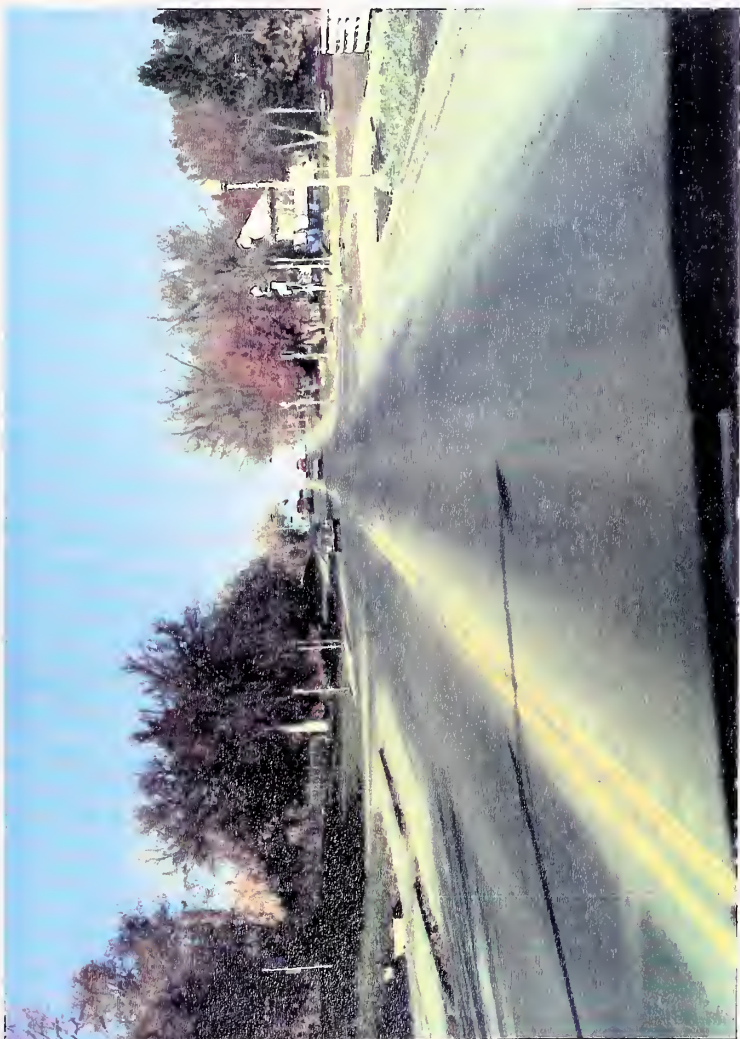
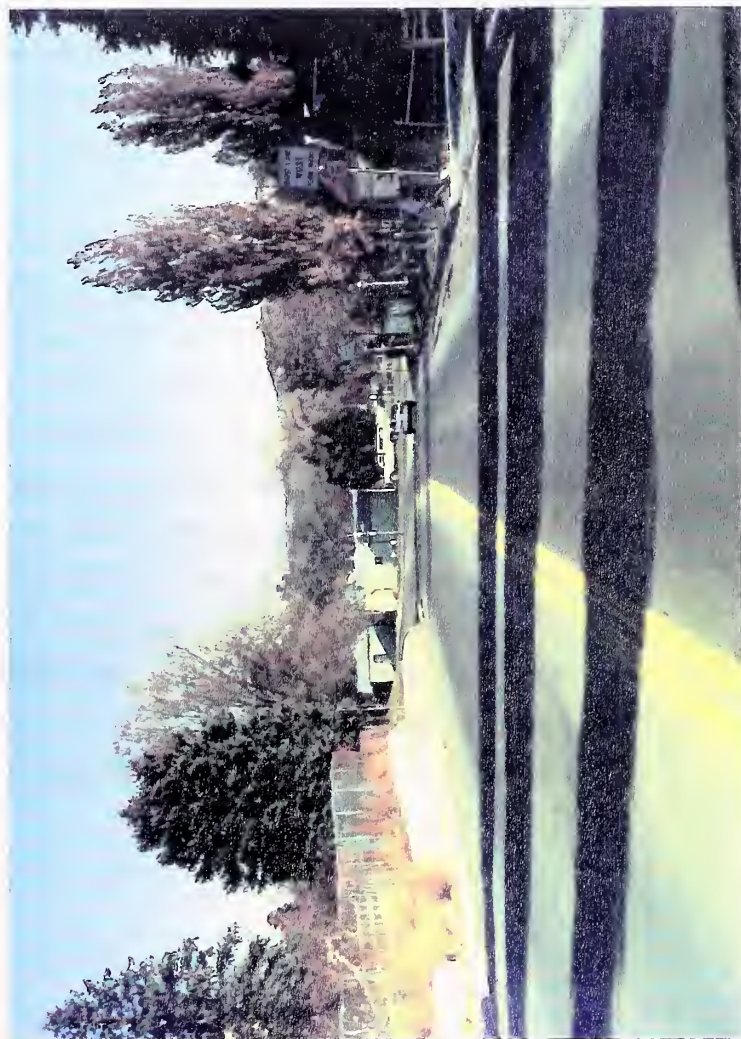
8TH ST. W. LOOKING SOUTH

LEWIS AVE. LOOKING WEST

8TH ST. W. LOOKING NORTH

LEWIS AVE. LOOKING EAST

Lewis Avenue is an east-west collector street and 8th Street West is a north-south collector. Because of an offset jog in the Lewis Avenue alignment this intersection was reconstructed approximately 18 years ago. A S.I.D. utility project reconstructed the western approach to this intersection in 1990. A portion of the accident experience occurred prior to the 1990 project and some accident exposure was missing during the period when the intersection was closed. The most predominant accident at this intersection was the angle accident, with 6 occurring during the reporting period. Various other types of accidents occurred which reflects the complex nature of this intersection.

Various methods of reducing the Lewis Avenue crossing distance and reconfiguring the intersection were made in attempt to reduce accident potential at this intersection. No alternative was found which would accomplish this task. The only short term improvements that can be recommended at this location deal with upgrading signing and striping to current recommended standards. Plastic marks should replace paint wherever possible since traffic volumes are high and the existing painted marks wear very quickly. Since a significant percentage of accidents occurred at night, it is recommended that improved lighting be installed in the intersection area. The intersection crossing gaps are critical and lighting will aid in driver's perception of approaching vehicle speeds. Future improvements will most likely require extensive reconstruction and right-of-way acquisition in this area if traffic volumes continue to increase.
